Inspection Report

Property Address: 14225 FM-316 N Eustance TX 75124

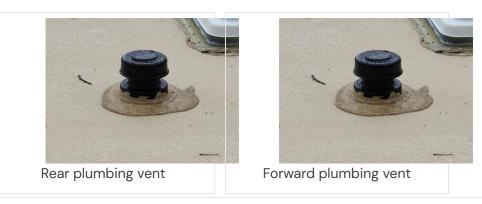
Sealant around the plumbing vent. This area requires regular maintenance by a qualified RV technician

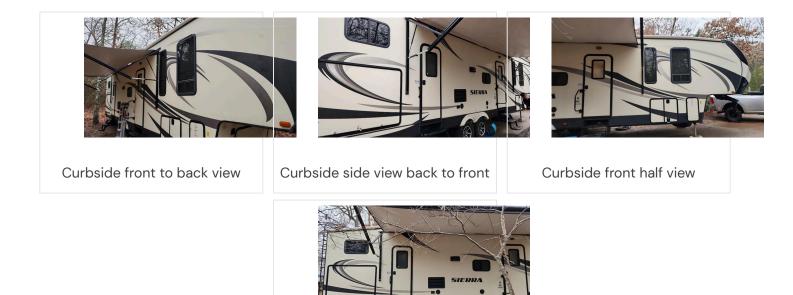
Curbside full side view rear half

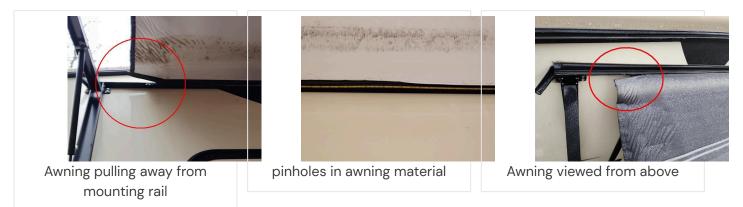
5.1 FABRIC CONDITION

The awning is not attached to the trim rail at the rear end of the awning, and the inspector also noted a small pinhole along the top.

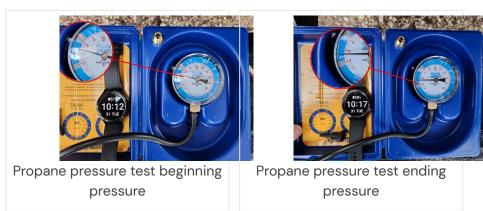
13.1 LP LEAK SYSTEM TEST

The time pressure drop test failed. We started with 8 in of water column and ended with six. It is recommended the propane system be repaired by a qualified RV technician.

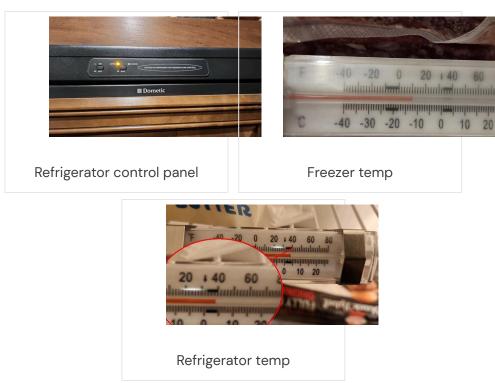
(1) The refrigerator control panel is located above the door. The freezer and refrigerator temperature are in the normal range.

(2) The Dometic refrigerator has had the recall kit installed as evident by the tag at the exterior.

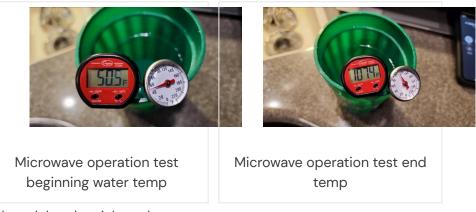
(1) The microwave operation was tested by heating a cup of water for 1 minute and recording the water temp.

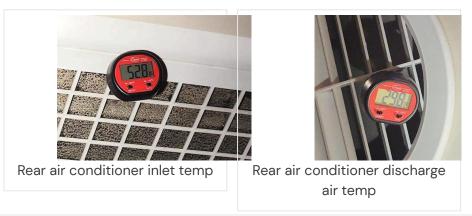
The inspector tested the air conditioner by measuring the inlet and outlet air temperature, referred to as delta T
